The Study Of Landslide In Tomohon Manado Road Path

S T R Tewel^{1*}, H S Sulastriningsih², Murdiyanto³

Geography Department Social Science Faculty Universitas Negeri Manado Manado,
Indonesia

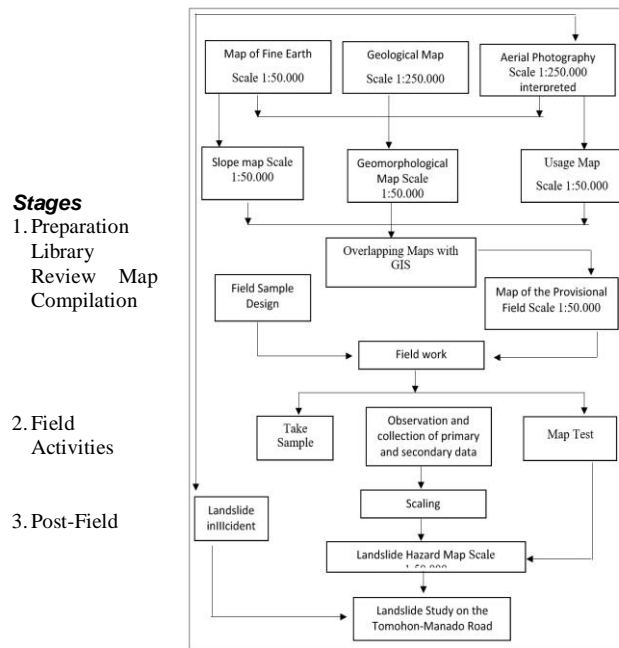
Figure 1. Elements of Commercialized Geotourism Product Package.

Research flow chart:

This study uses a geomorphological approach with a terrain as a unit of analysis. The research methods used included map analysis, interpretation of aerial photographs / images, observations, field measurements to obtain physical data as well as laboratory analysis of soil samples. To get a landslide hazard map scale of 1: 50 000 is done by respecting the terrain parameters.

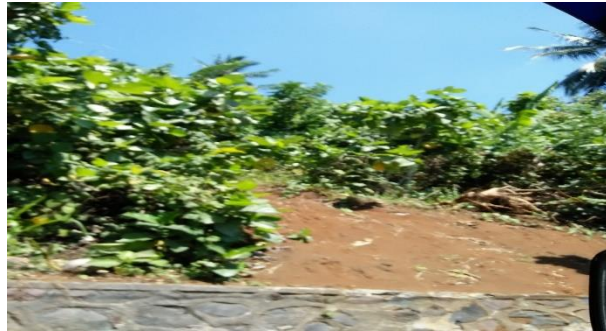
Figure 3. Landslide on a gentle slope

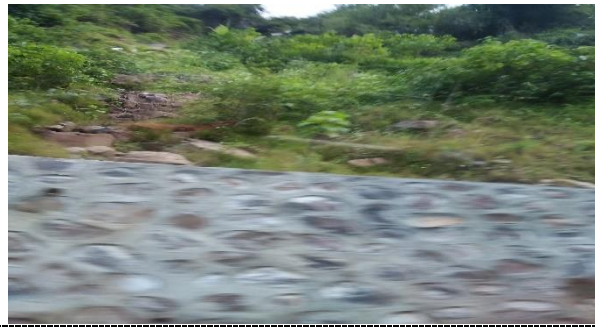
Figure 4. Slide Type Slide.

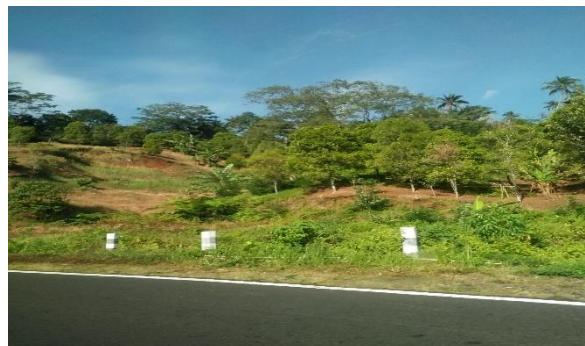
Figure 5. Slump / Slash Type Landslide

Landslide conditions in the Tomohon-Manado route are also classified into three hazard level categories, based on research / observation based on two types of landslide types, namely slide type landslides that occur at locations with steep slope slopes and slump or sloping types which this phenomenon occurs at locations with slope and sloping (Figures 3 and 4) and also the point of landslide occurring in the Tomohon - Manado route was found both on the slope of the steep slope to the sloping land (Figures 2 and 5)
